**RE: SWACC PROPERTY & LIABILITY INSPECTION**

# SWACC PROPERTY & LIABILITY INSPECTION

*December 2009*

**SAN JOSE/EVERGREEN  
COMMUNITY COLLEGE DISTRICT**

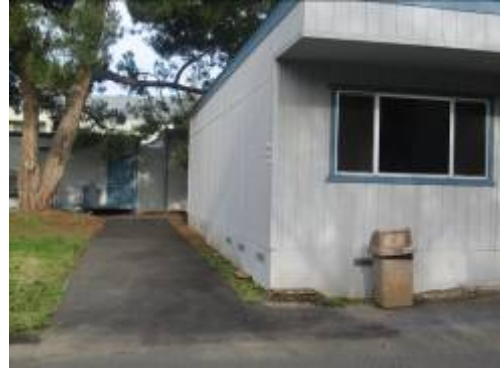
### **Trash Receptacles**

Should be removed from flammable materials, next to walls and under building eaves.

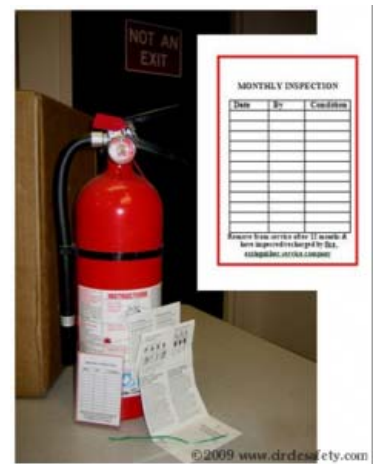
### **Fire Extinguisher**

Extinguishers are required to be visually inspected at least once per month. To ensure the inspections are done, all responsible parties should initial and date the service tag, which is attached to each extinguisher at the annual servicing.

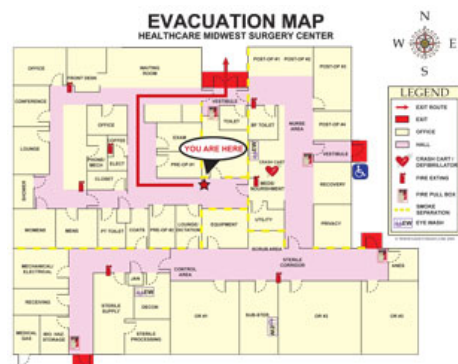
### **Evacuation Maps**

Evacuation maps are an integral part of an effective Emergency Action Plan. During the inspection, it was noted that many classrooms throughout the District did not have evacuation maps posted. Evacuation maps should be site maps with an approved evacuation route for the room clearly marked on the map. The map should be conspicuously posted at the designated exit door in each room.

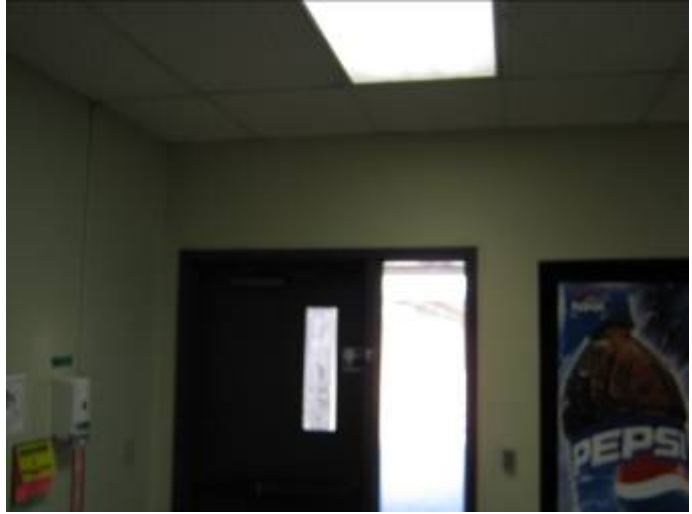
### **Exit Signs**

Exit signs should be installed 6" above any door that require identification as an exit. The sign should be adequately illuminated or be of a glow-in-the-dark type.

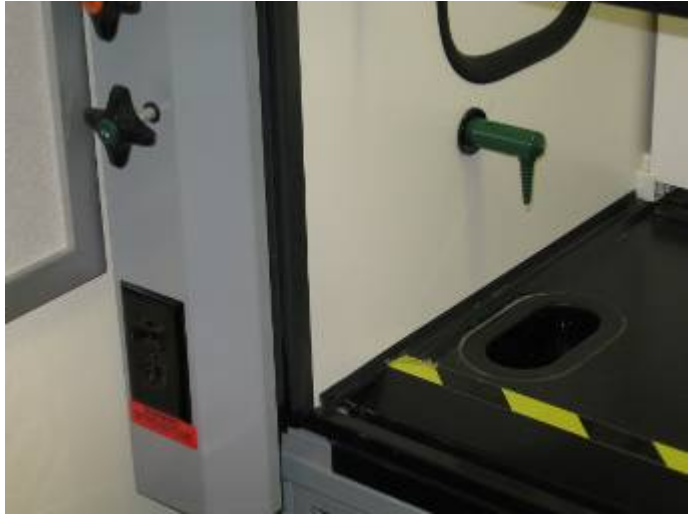
##### **Ventilation Hoods**

When sinks are operable, the use of nearby electrical circuits increases the risk of electric shock injuries. Therefore, the electrical circuits/outlets should be equipped with ground fault interrupters.

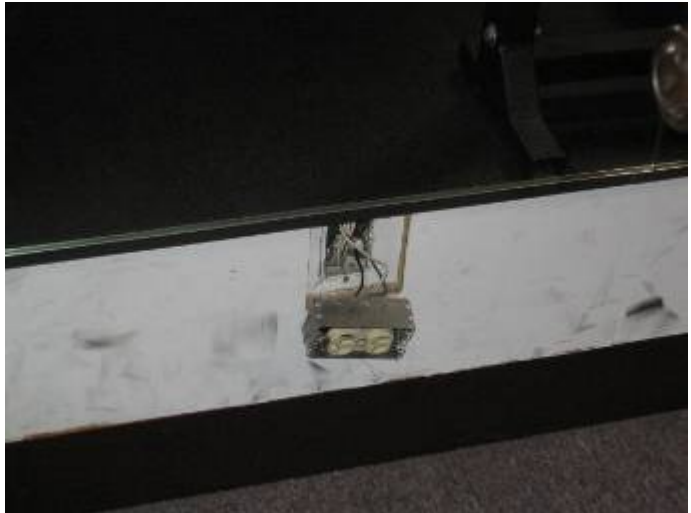
##### **Electrical Outlets**

Multiple electrical outlets not secured/missing wall plate. The electric receptacle(s) was (were) defective and should be repaired/replaced or the circuits de-energized. Electric equipment firmly secured to the surface on which it is mounted.

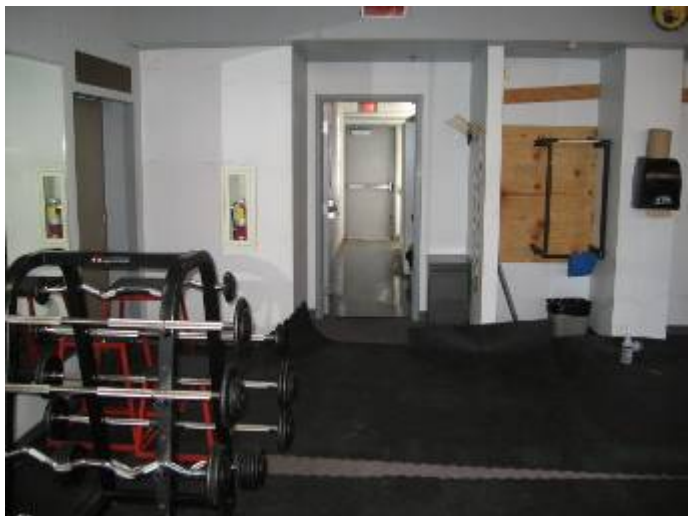
##### **Floor Mats**

The padding on the floor was torn and not secured should be replaced to eliminate the hazard that was observed.

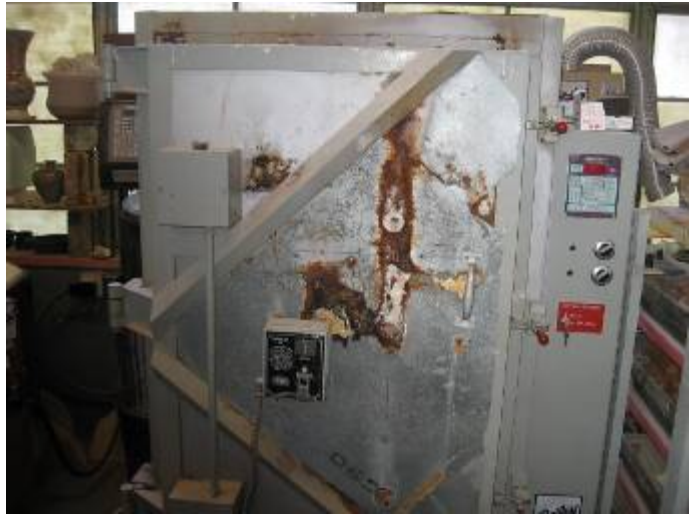
Doors/walls damage on kilns, damaged or decaying. Requires repair with in manufacture's guidelines.

The Kilns should be provided with a "DANGER-HOT" sign.

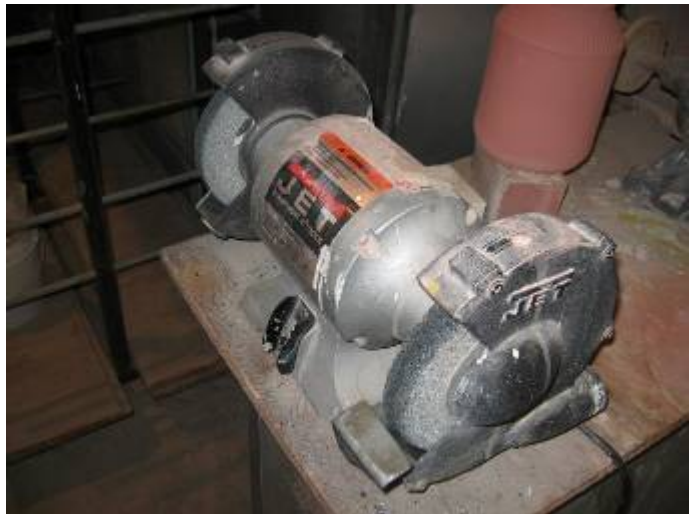
#### **Bench Grinder**

Missing tongues, tool rests, eye shield. All grinders should be inspected and repaired/adjusted to meet the following requirements: tongue guards attached and adjusted to within 1/4" of the grinding wheel. Tool rests attached and adjusted to within 1/8" of the grinding wheel, safety shields over the grinding wheels/brushes safety shields.

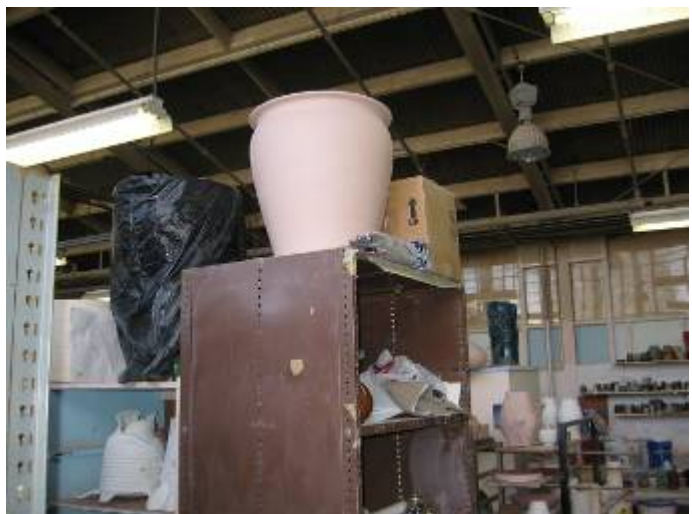
#### **Storage**

Heavy objects stored on top of shelves create a falling hazard and should be removed and stored at a lower level.

The cabinet should be anchored to prevent tip over or inadvertent movement.

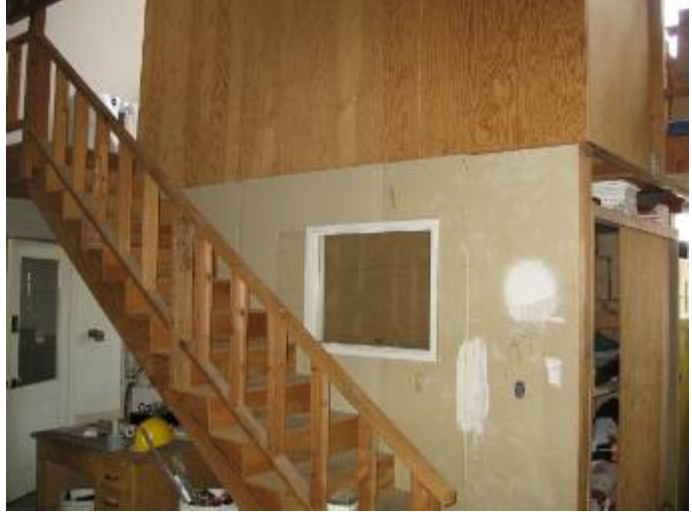
#### **Floor Load Limit Signage**

The weight limit should be determined for mezzanine. The limit should also be posted in a clearly visible area, and the load limit enforced.

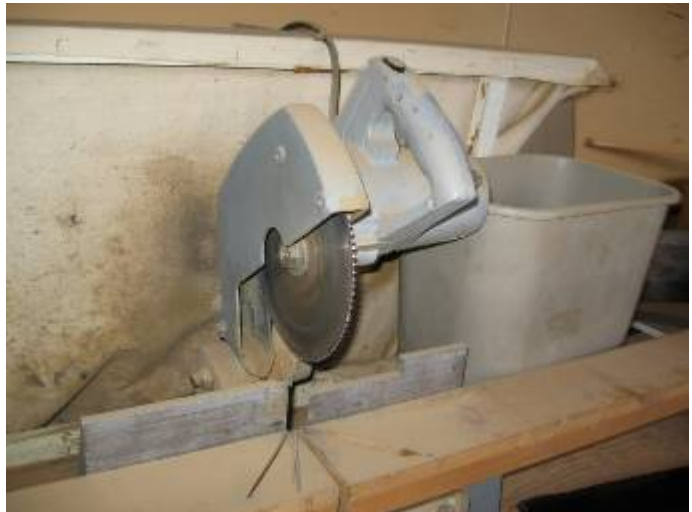
#### **Miter Saw**

The Miter Saw blade guard is missing. A guard should be installed and in place during use or the equipment removed. The guarding device should be designed and constructed to prevent the operator from having any part of his body in a danger zone during the operating cycle.

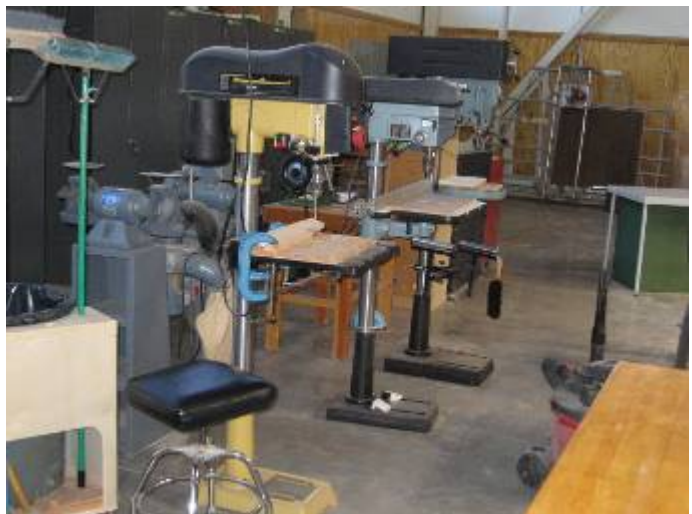
#### **Drill Press**

Bench-style and unstable freestanding equipment, i.e., grinders, vises, miter saws, and drill presses, should be secured to the bench or floor, as appropriate, to prevent them from moving or tipping over during use.

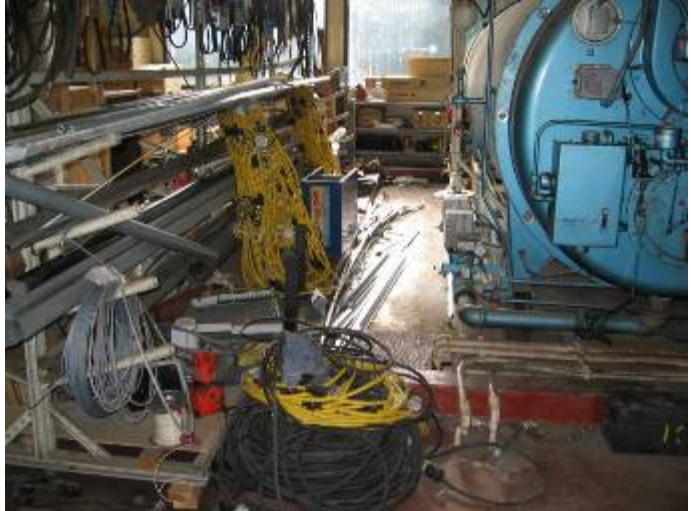
#### **General Housekeeping**

Good housekeeping conditions shall be maintained at all times. The area should be kept in a clean and orderly condition. Aisles and passageways should be kept clear and in good repair.

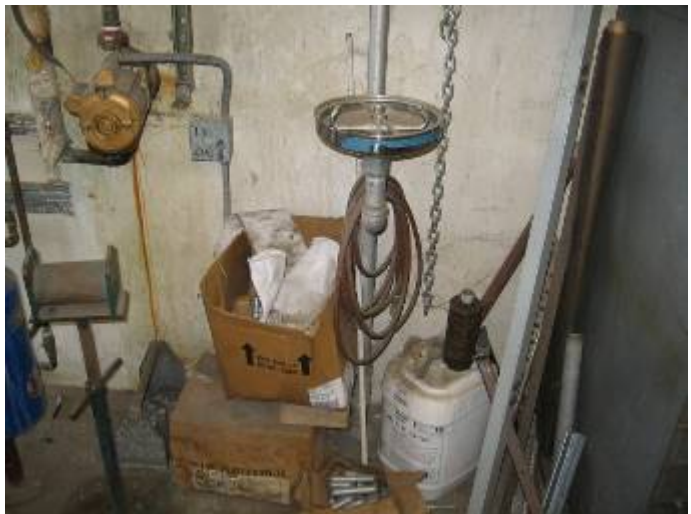
#### **Eyewash/Area**

Proper functioning eyewash and deluge showers are essential to the reduction of the severity of chemical exposure injuries. Therefore, all emergency eyewash stations and deluge showers should be inspected and tested at least monthly to ensure proper operations. All inspection information and results should be documented and kept in a central location for at least one year.

Housekeeping should be improved to eliminate restricted access that was observed.

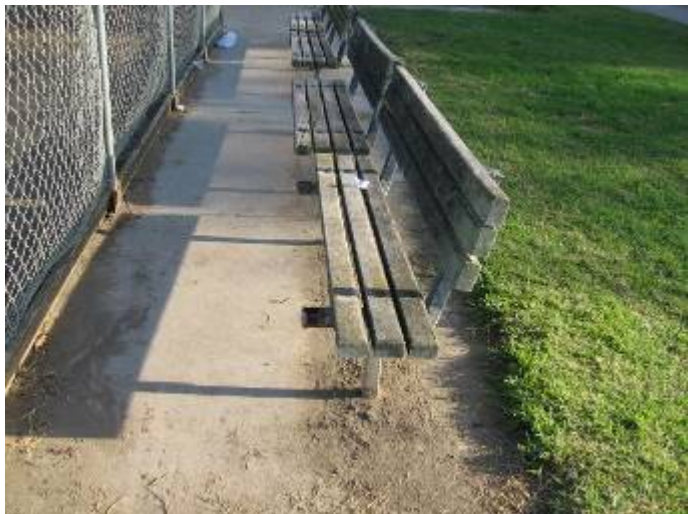
#### **Players Bench**

All wooden “players” benches that are cracked, splintered, rotted, and/or broken should be repaired or replaced. Metal support brackets must not lack integrity.

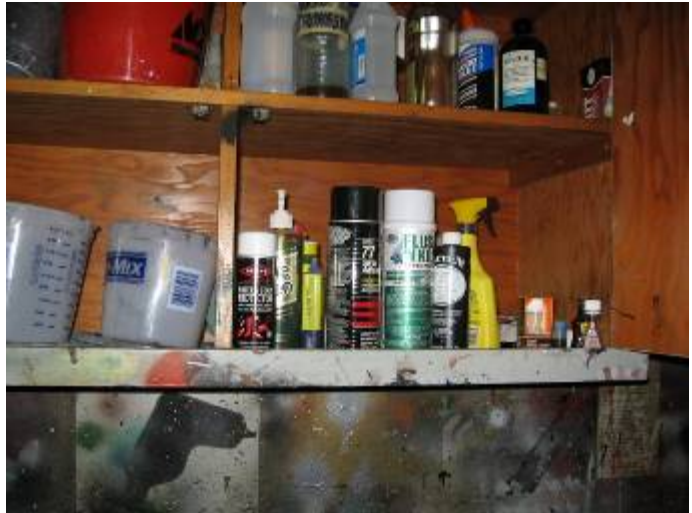
#### **Prop Department**

All flammable combustible liquids should be removed from the wooden cabinet and stored in an approved cabinet or an area designed for flammable liquid storage.

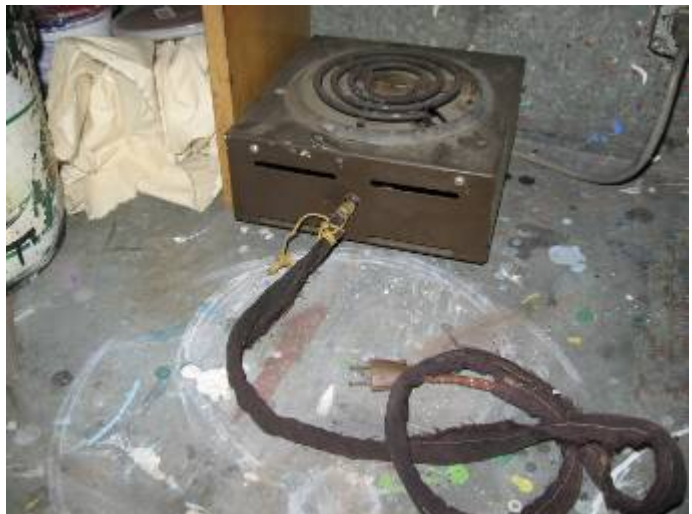
#### **Hot Plate**

Never use power cords with broken/cracked insulation, tape-covered splices, or other makeshift repairs/connections. The hot plate has a defective electric cord. The cord should be repaired, replaced or the unit removed from service.

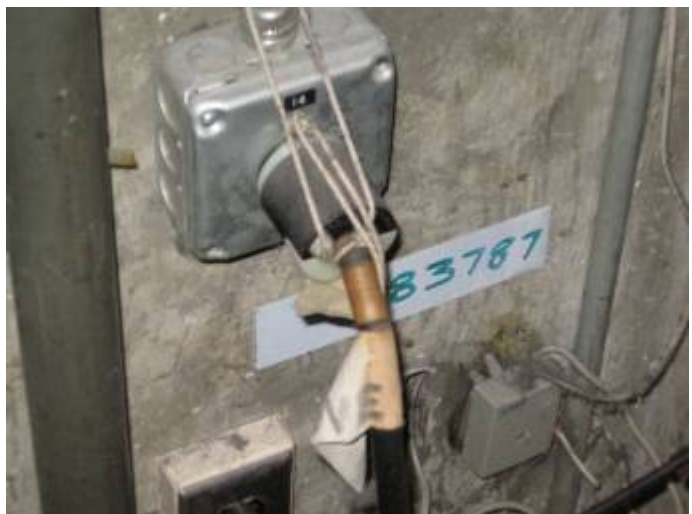
#### **Stage Area**

The electric receptacle(s) was (were) defective and should be repaired/replaced or the circuits de-energized.

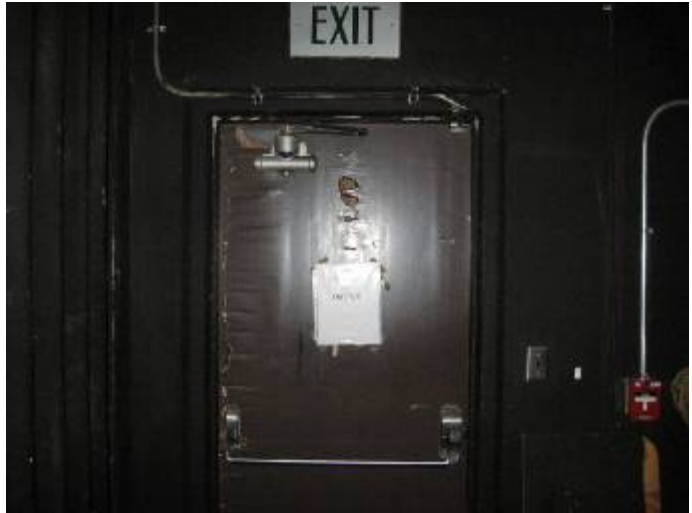
#### **Outside Exit Door**

Exit signs, when lit, should be clearly visible; therefore, all defective and/or missing sign light diffusers should be replaced.

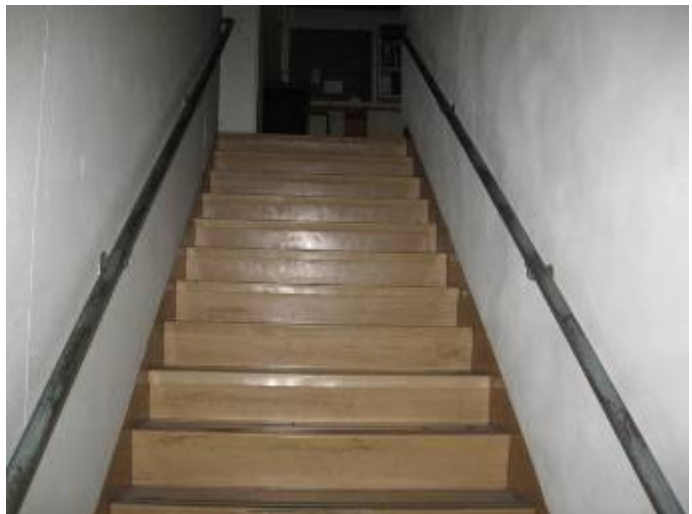
#### **Control Both Stairwell**

Low-level floor lighting should be provided to illuminate the aisle/stairs. These lights should be incorporated into the emergency lighting system.

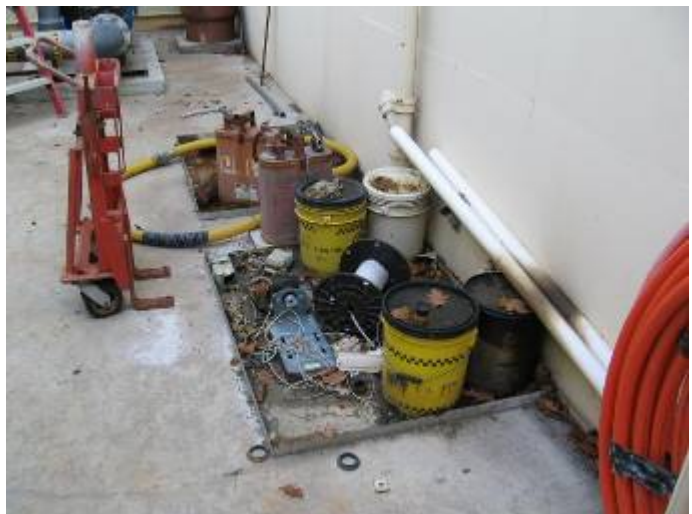
#### **Hazardous Material**

Flammable and combustible materials not properly sorted properly throughout department. To be stored in an approved cabinet or an area designed for flammable liquid storage.

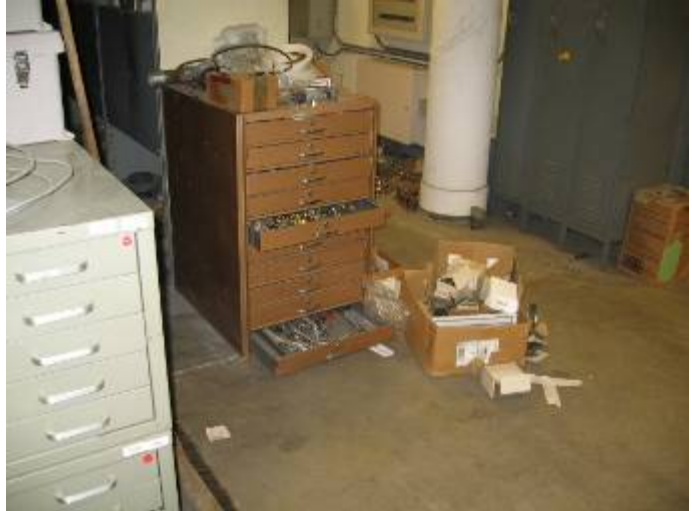
#### **Housekeeping**

Housekeeping should be improved. The area should be kept in a clean and orderly condition. Aisles and passageways should be kept clear and in good repair.

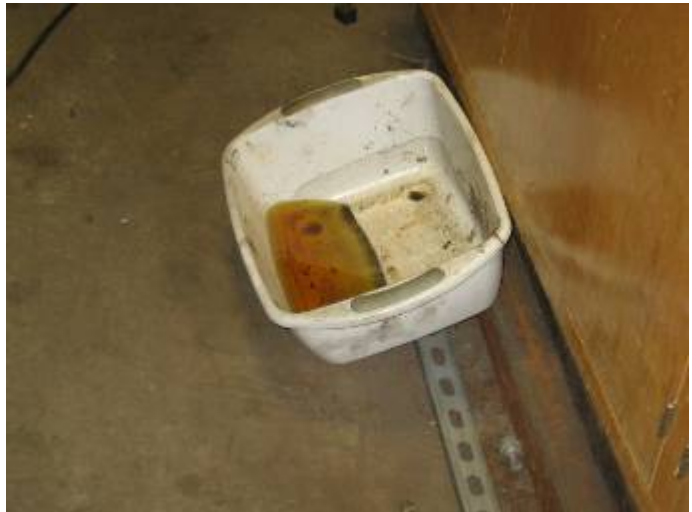
#### **Hazardous Waste Petroleum**

Used oil was stored in an improper container. An appropriate chemical container should be obtained (available through chemical suppliers) and the contents transferred using proper safety precautions.

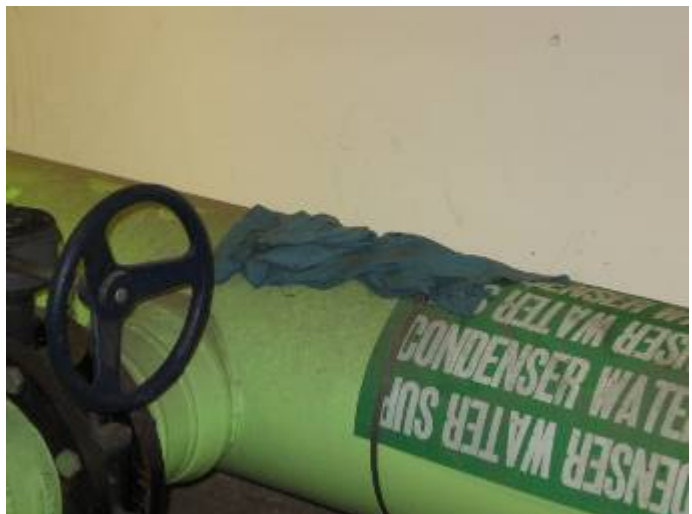
#### **Solid Shop Rag**

A metal container with an attached, self-closing cover should be provided for the storage of oily and solvent soaked rags.

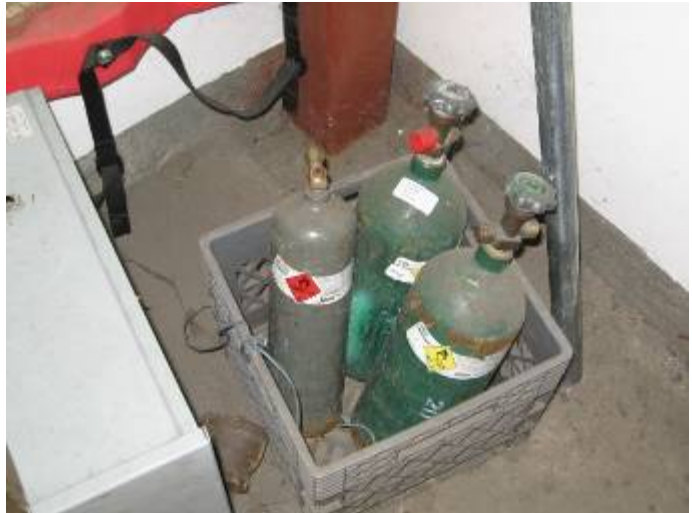
#### **Oxygen-Fuel/Gas Cylinders**

The spare acetylene and oxygen cylinders are not properly stored and should be separated by a 20' space or a 5' non-combustible wall having a 1/2-hour fire resistive rating. Assigned storage spaces shall be located where cylinders will not be knocked over or damaged by passing or falling object.

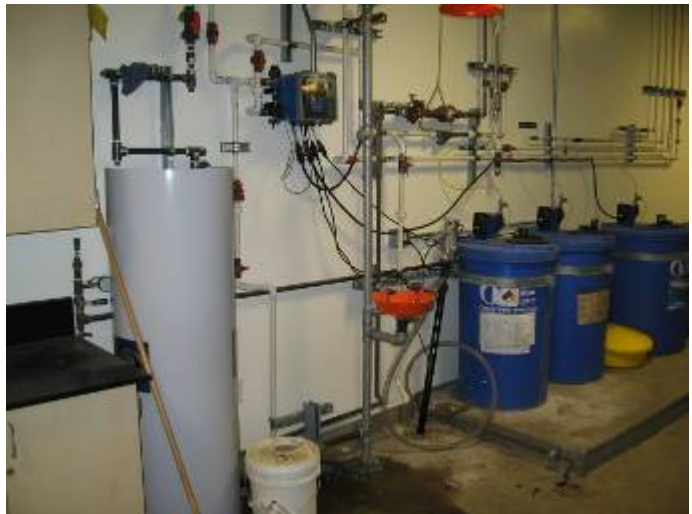
#### **Eyewash**

Proper functioning eyewash and deluge showers are essential to the reduction of the severity of chemical exposure injuries. Therefore, all emergency eyewash stations and deluge showers should be inspected and tested at least monthly to ensure proper operations. All inspection information and results should be documented and kept in a central location for at least one year.

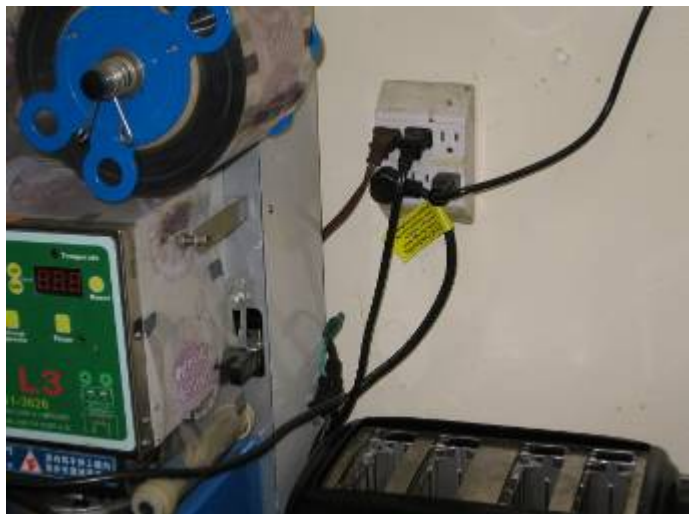
#### **Electrical outlet**

The “octopus” collection of electric power cords to one electric outlet should be replaced with U.L. approved multi-outlet electrical receptacles to reduce fire and electric shock hazards. Only power strips equipped with internal fuses are acceptable as permanent wiring.

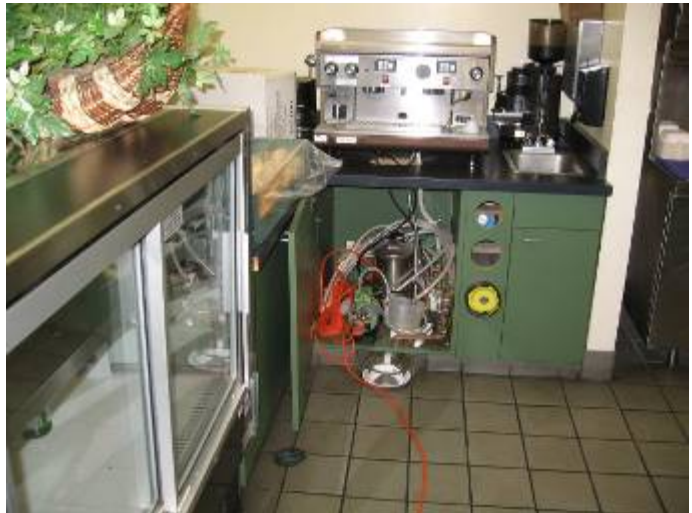
**Electrical Extension Cord**

Extension cord utilized as permanent wiring to espresso machine. Multi-outlet receptacles should be installed in order to eliminate the use of long extension cords to wall power outlets. The cords create trip/fall and electric shock hazards.

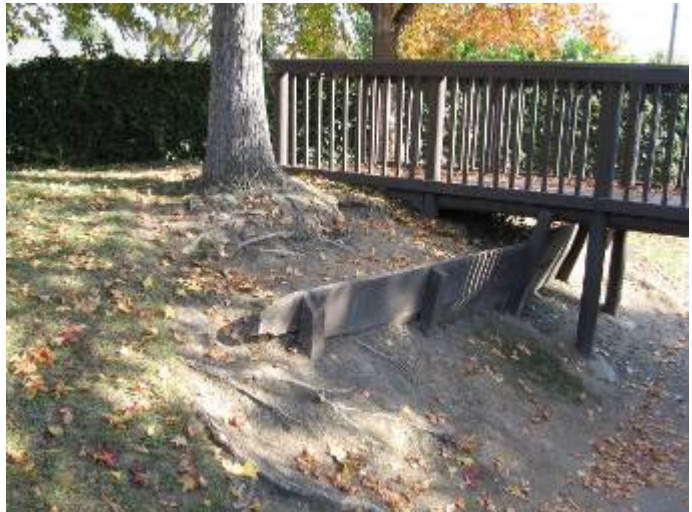
(1)

Deterioration of wooden wall. Children often utilize this area to play

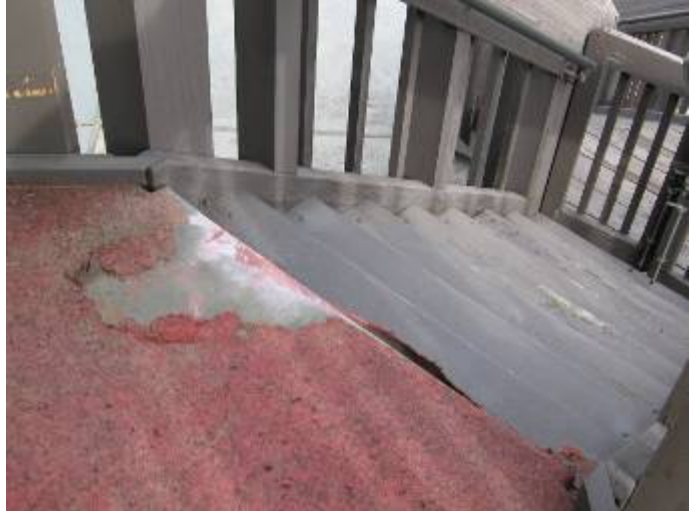
**Second floor Carpet**

The raised/torn carpet creates a trip/fall hazard and should be removed or re-installed to eliminate the hazard.

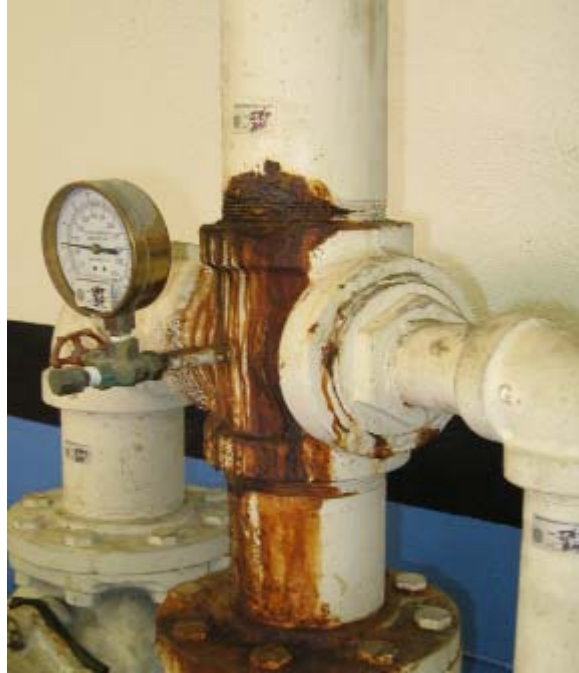
Deteriorating fire riser coupler, water visibly emitting. Requires repair immediately, protect integrate of fire suppressions system.

Faculties Director Robert Diaz immediately contacted discussed issue.

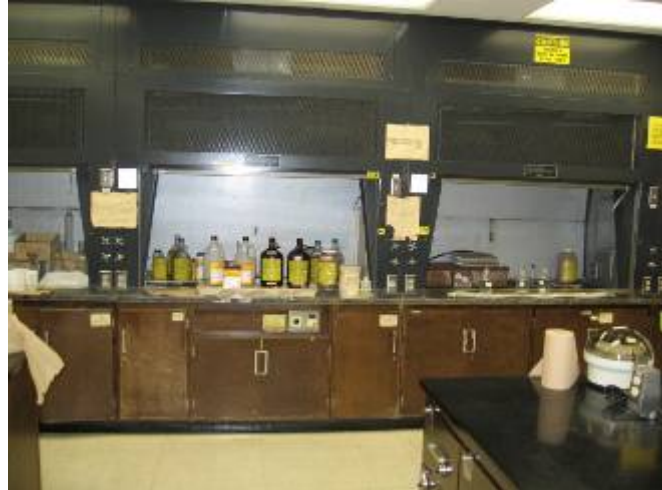
##### **Science Lab Ventilation Hoods**

Hazardous liquids stored under the ventilation hood should be removed to provide adequate space and safe conditions for lab experiments conducted under the hood.

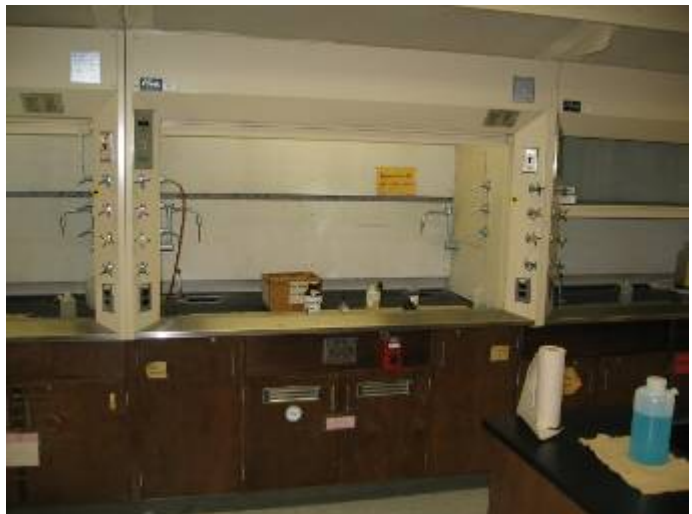
##### **Ventilation Hoods**

When sinks are operable, the use of nearby electrical circuits increases the risk of electric shock injuries. Therefore, the electrical circuits/outlets should be equipped with ground fault interrupters.

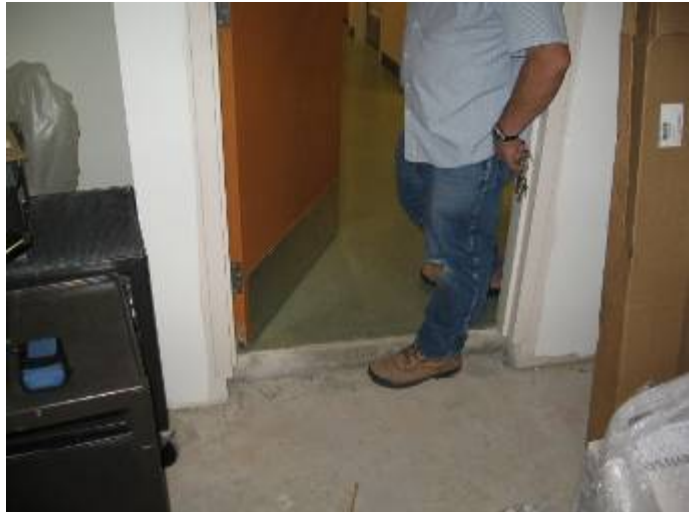
#### **Doorway**

Unmarked change in evaluation, stepping in and out of area potential slip, trip, and fall. Entrance should be identified or posted.

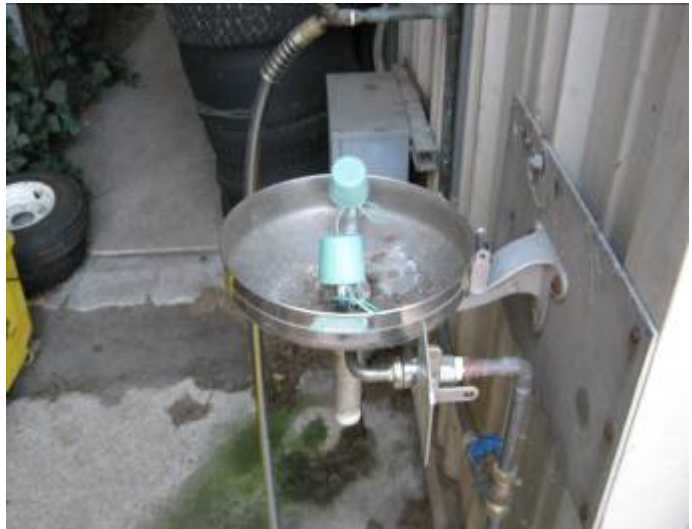
#### **Eyewash/Area/Housekeeping**

Proper functioning eyewash and deluge showers are essential to the reduction of the severity of chemical exposure injuries. Therefore, all emergency eyewash stations and deluge showers should be inspected and tested at least monthly to ensure proper operations. Housekeeping should be improved to eliminate access to eyewash area.

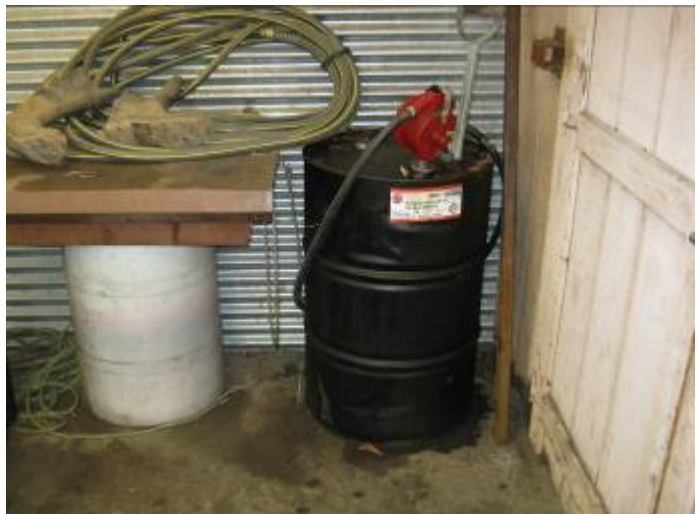
#### **Hazardous Material Storage**

A 55-gallon drum of oil was observed in side the landscaping shield. As part of an on-site management program for hazardous wastes, each waste container should be provided with a means of secondary containment. Secondary containment can be achieved through the use of concrete berms or polyethylene spill skids, which will retain any leaks or spills.

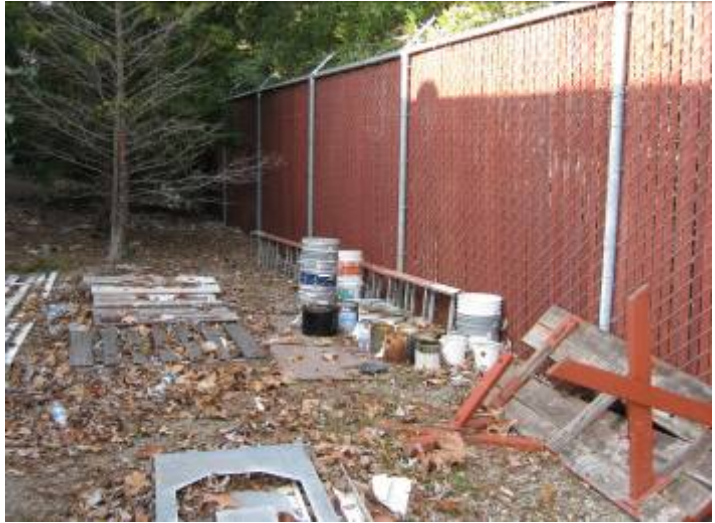
#### **Housekeeping**

Should be improved to eliminate trip hazard that was observed.

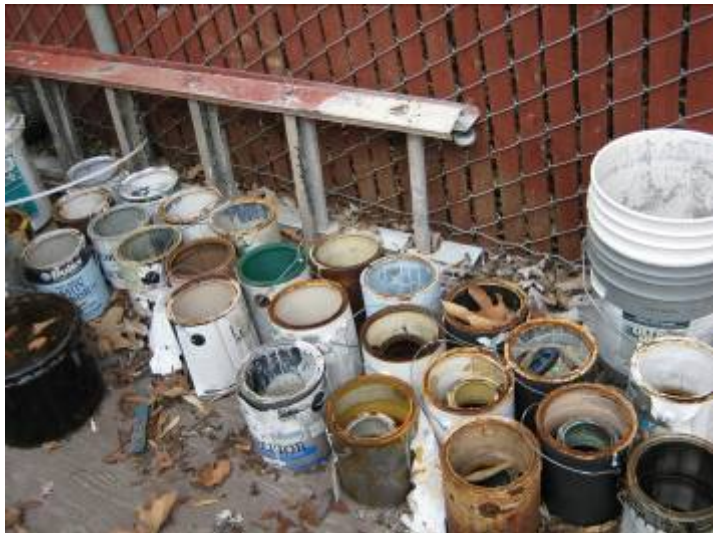
#### **Storage of Waste Paint**

Keep the containers sealed or closed at all times. Containers must be protected from the weather and physical damage. Train personnel in the safe use, storage, and shipping procedures for waste paint.

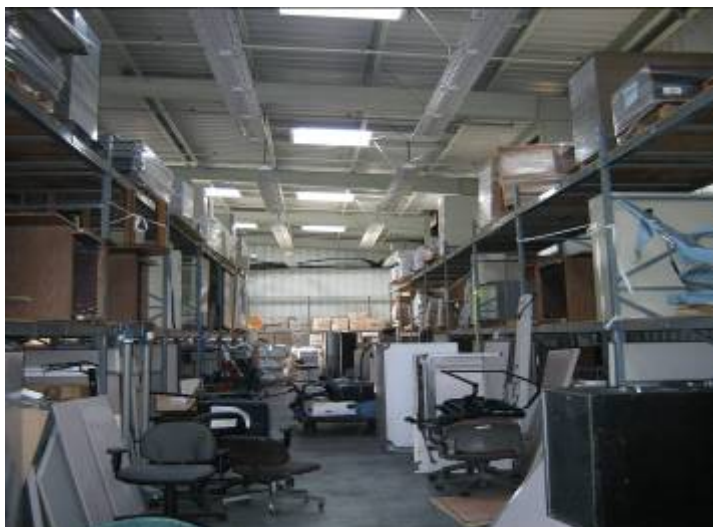
#### **Storage Area**

The heavy objects on top of the shelves creates a falling object hazard and should be removed and stored at a lower level, or be stacked, blocked, interlocked and limited in height so that they are stable and secure against sliding or collapse.
